ATCX 442 Repair Update

6/29/2022

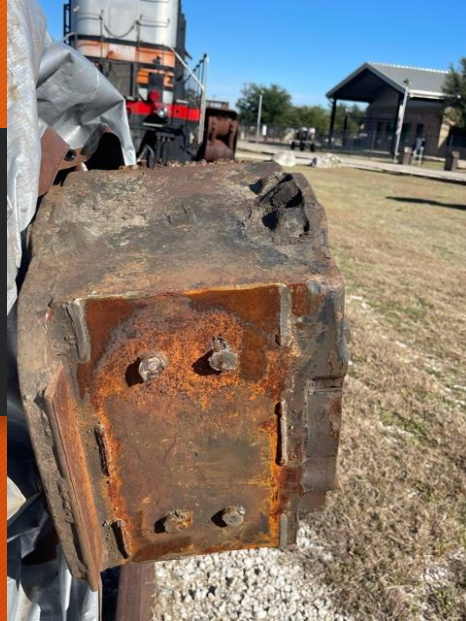
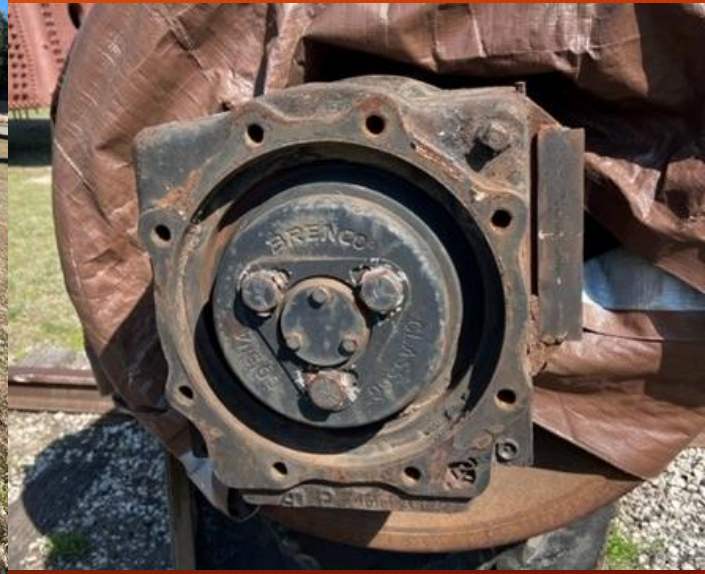
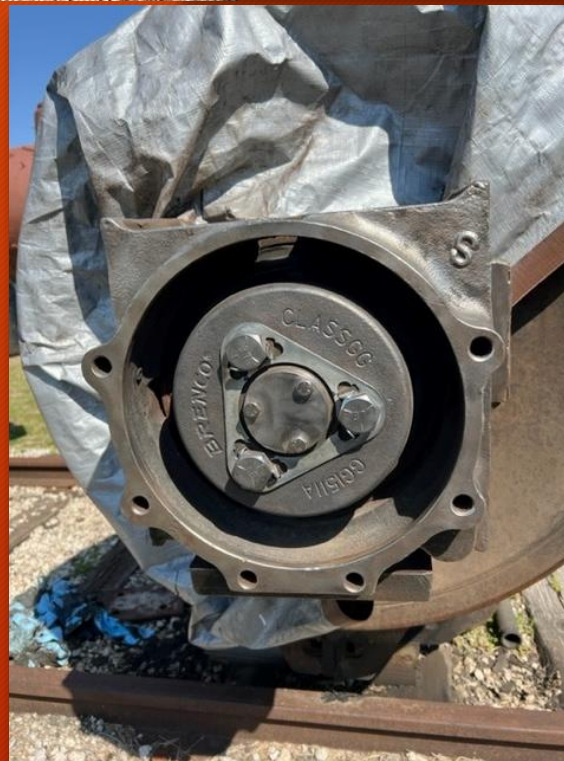
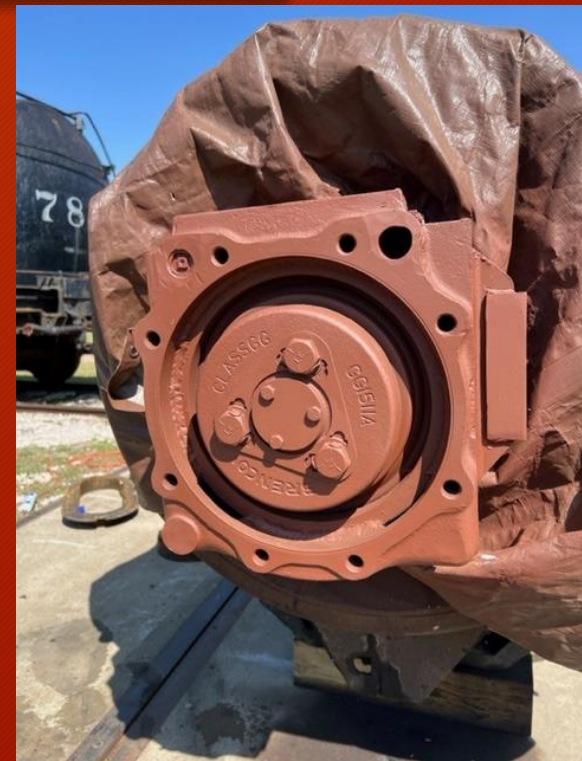
Bearing Boxes

- Journal boxes have been cleaned up and ground back to proper specifications.
- Primer paint has been used to reduce rust build up until paint is complete.
- Metal is on order to replace existing shim material with metal that will last in the high friction areas.
- Attached are the before and after pictures of work done so far.

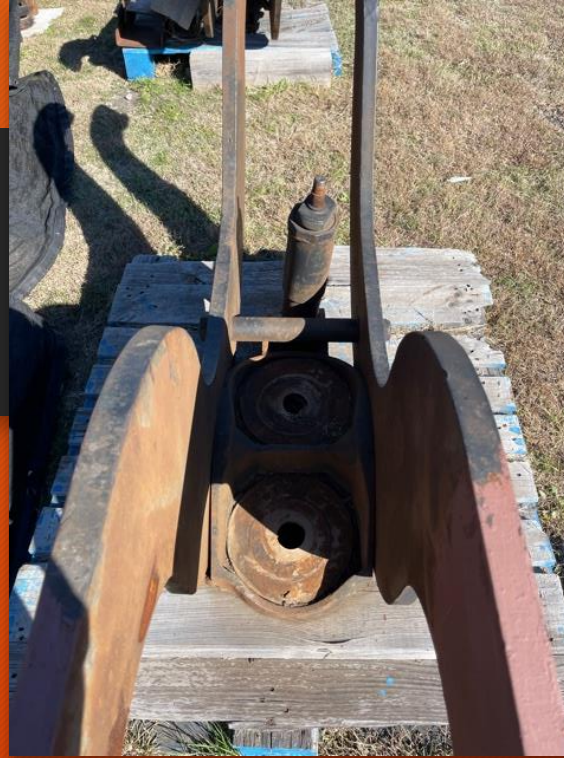
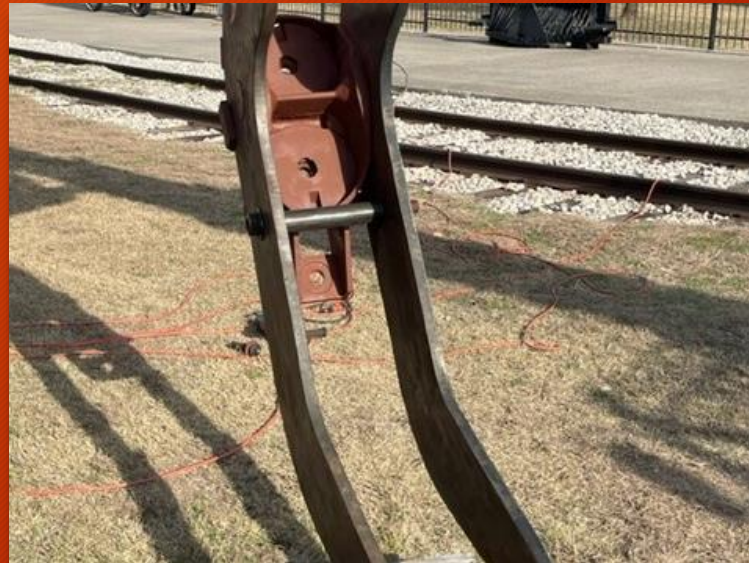
- Equalizers were cleaned and wire brushed to remove old paint.
- All cracks were welded, and spring pads replaced.
- New shock absorbers will be installed upon reassembly.

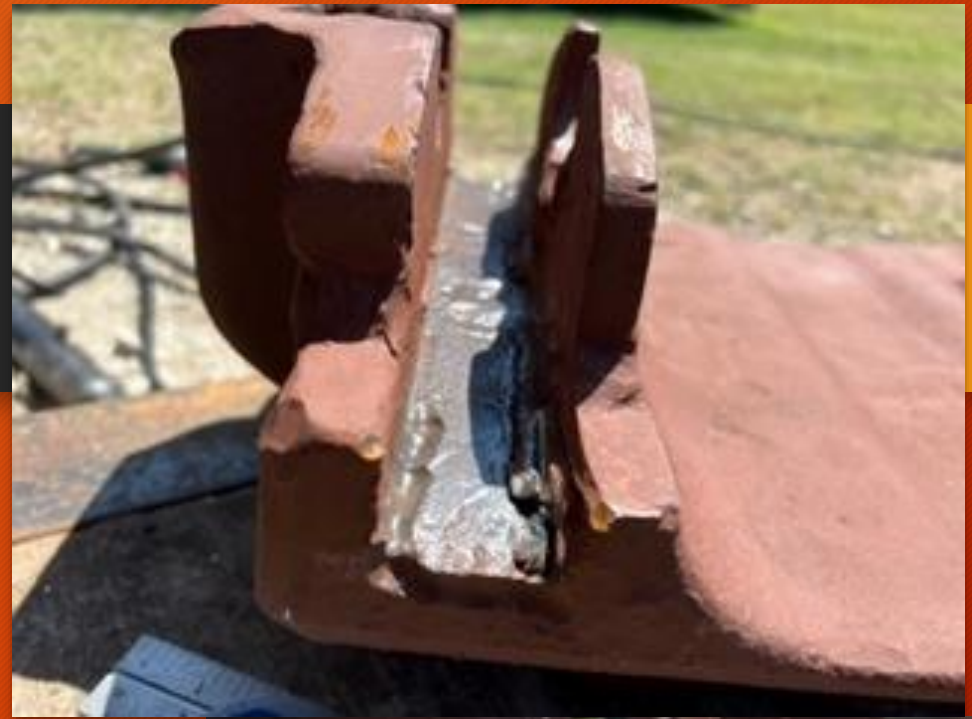
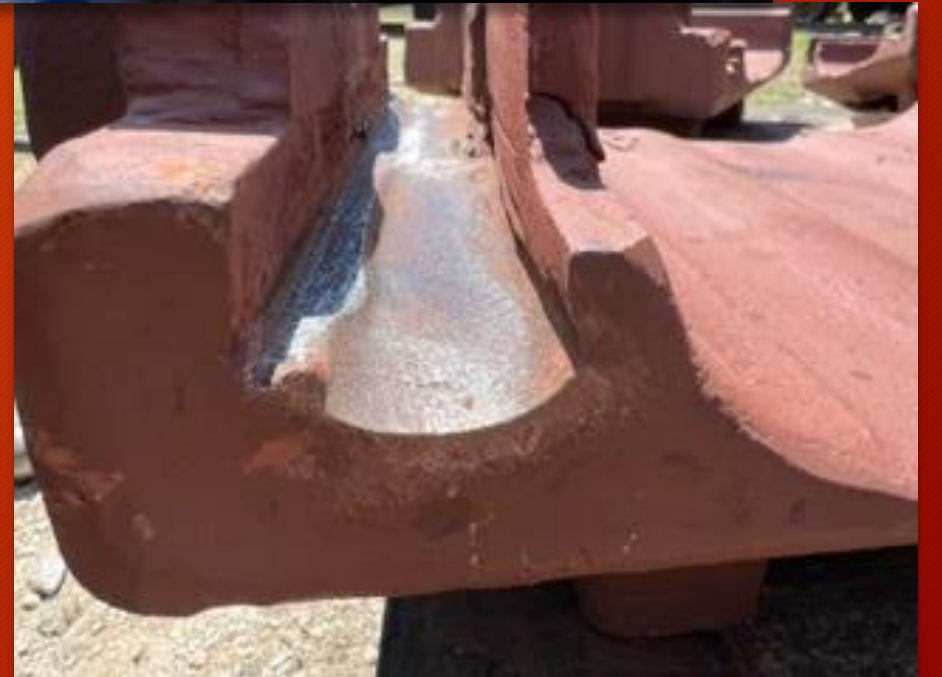
Equalizer Adapters

- The equalizer adapters were worn down to the point that the dimensions no longer matched each other.
- The adapter plates were taken to a machine shop where material was built up and then machined down to the proper sizes.
- This repair will ensure that the journal boxes will all ride at the same proper height.
- New wear plates will be added to keep the adapters from being damaged in the future.

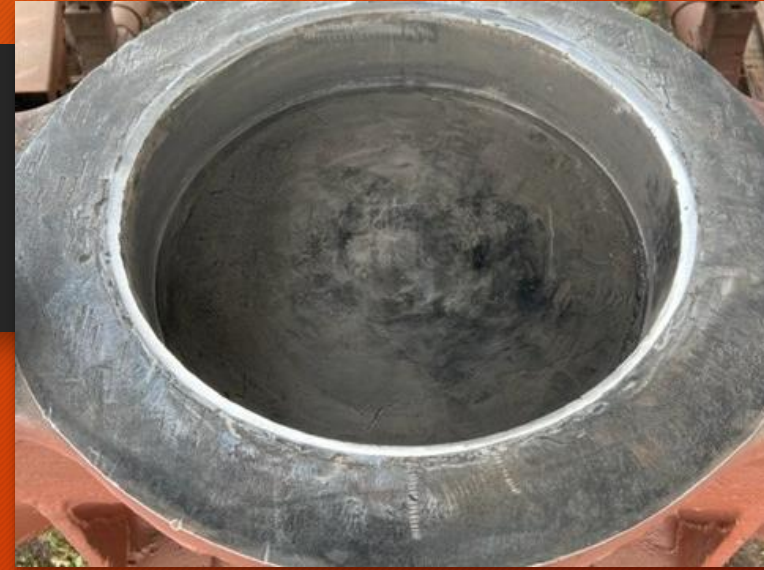
Center Bowl and Load Post

- The center bowl welds were broken around the top of the shim from a previous repair.
- The old weld was removed by a hand grinder and the shim was repaired.
- After reseating the new shim 7108 rod was used to weld the center bowl side shim back into place.
- The rest of the center bowl was cleaned, and all inclusions removed.

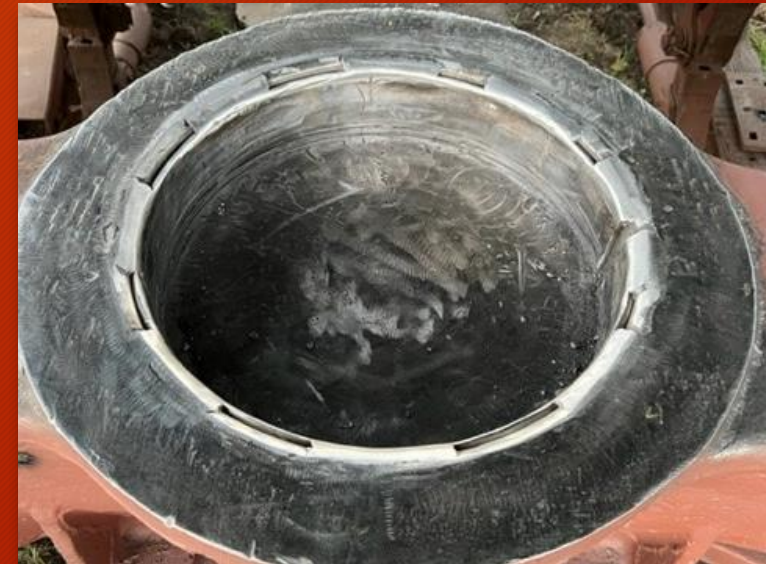
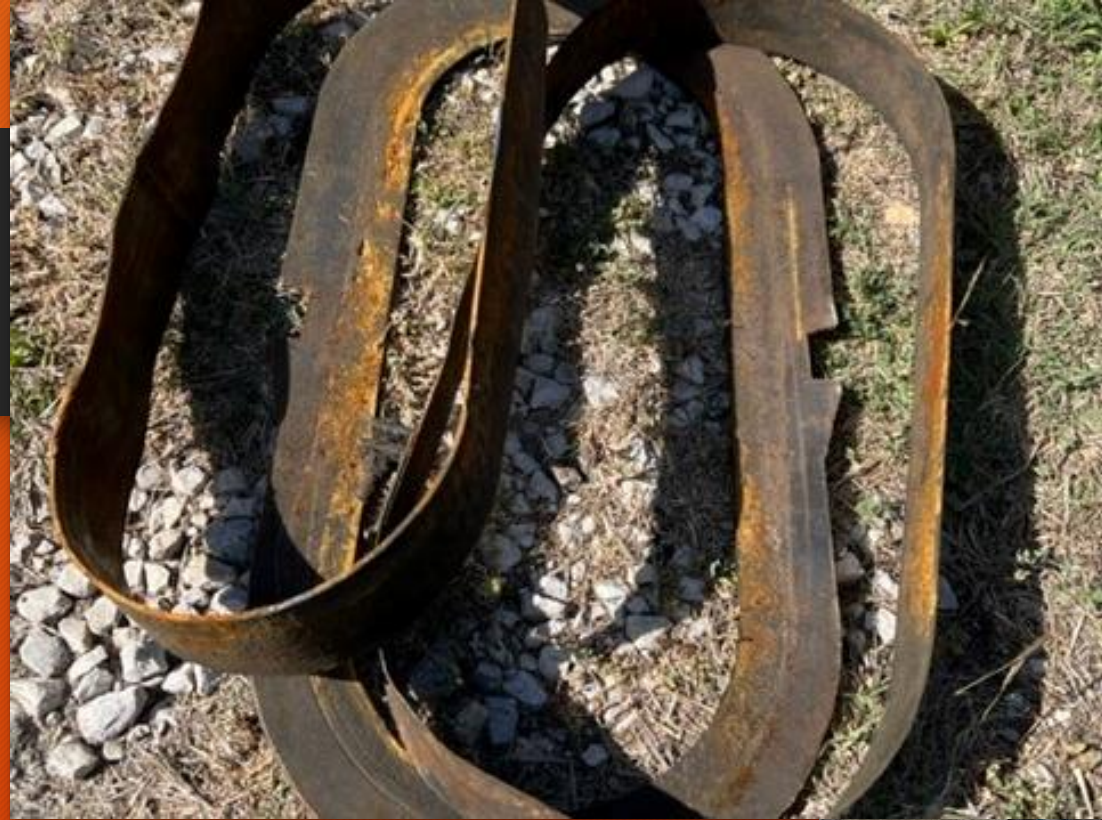
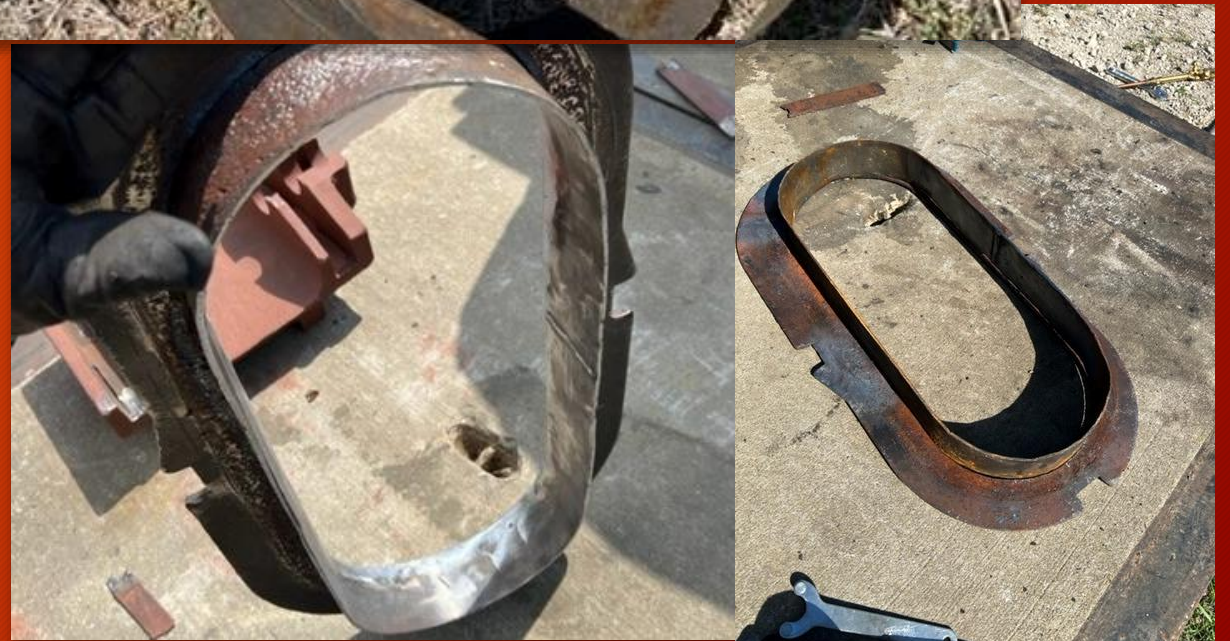
Center Bowl and Load Post

- The loading post felt brackets had been smashed during an old traction motor lift.
- New brackets could not be located so the old brackets had to be refurbished.
- The metal was heated and straitened, and new welds were made to reassemble the brackets.
- New felt will be applied before the truck is moved back under the locomotive.

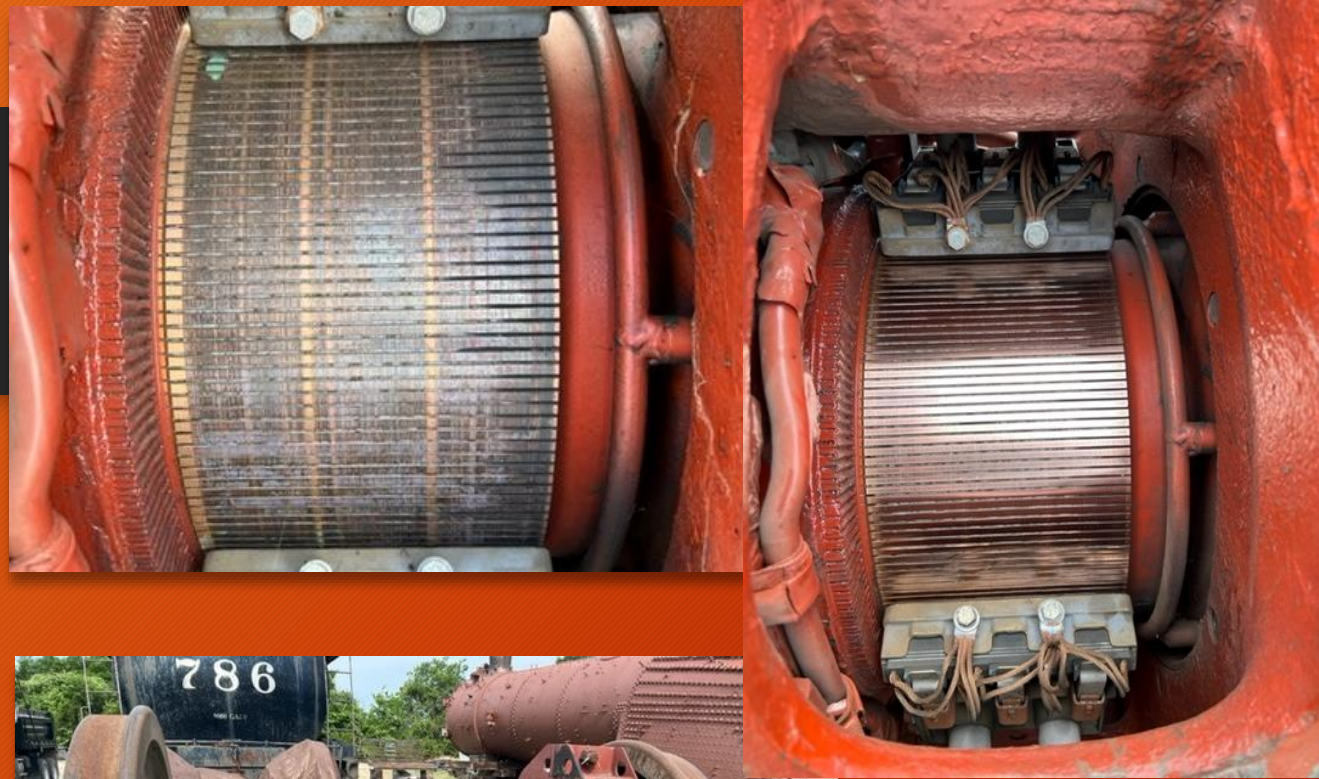
Traction Motor Clean Up

- Traction Motors (TMs) #4 and #6 were cleaned and painted.
- The insides were vacuumed out removing all cobwebs, dirt, and oil.
- Emery cloth was used to clean the commutators by hand to remove the tarnish from the copper.
- All the inspection covers were cleaned and repaired as needed. New seals were applied to all the inspection covers.
- The dust covers, gear boxes, and TM support bearings were resealed with high temp, high oil resistant RTV.

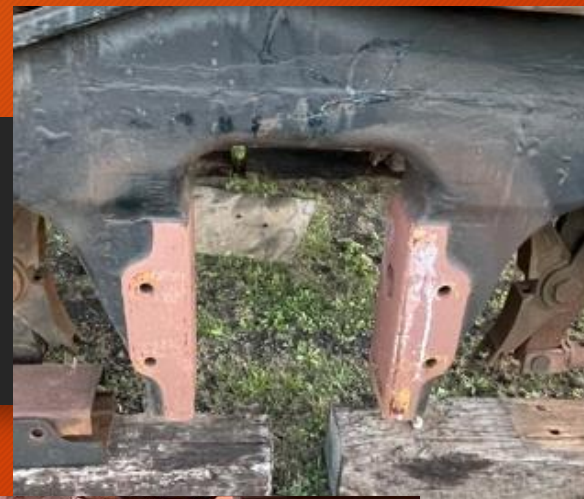
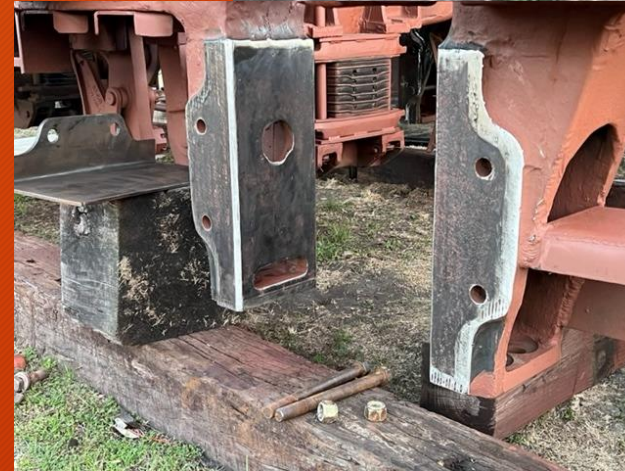
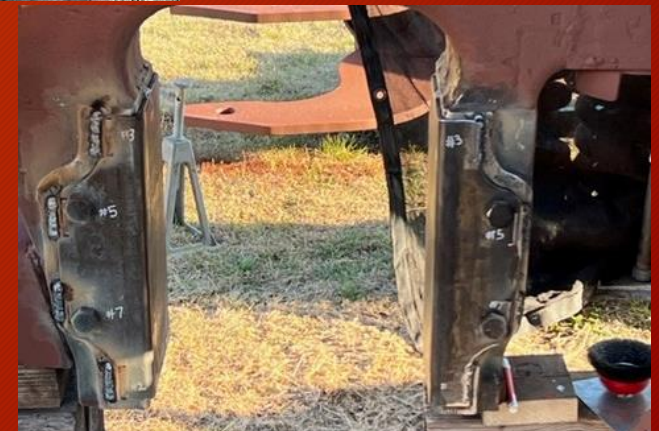
Pedestal Liners

- New pedestal liner shims have been welded in place on all 6 pedestal jaws.
- This corrects the problem of “cocked boxes” that could cause the journal boxes to bind in the frame.
- The welds were done using 7018 rod in the proper pattern prescribed by the maintenance manual.
- Each new pedestal liner was shimmed to ensure proper and exact clearance.

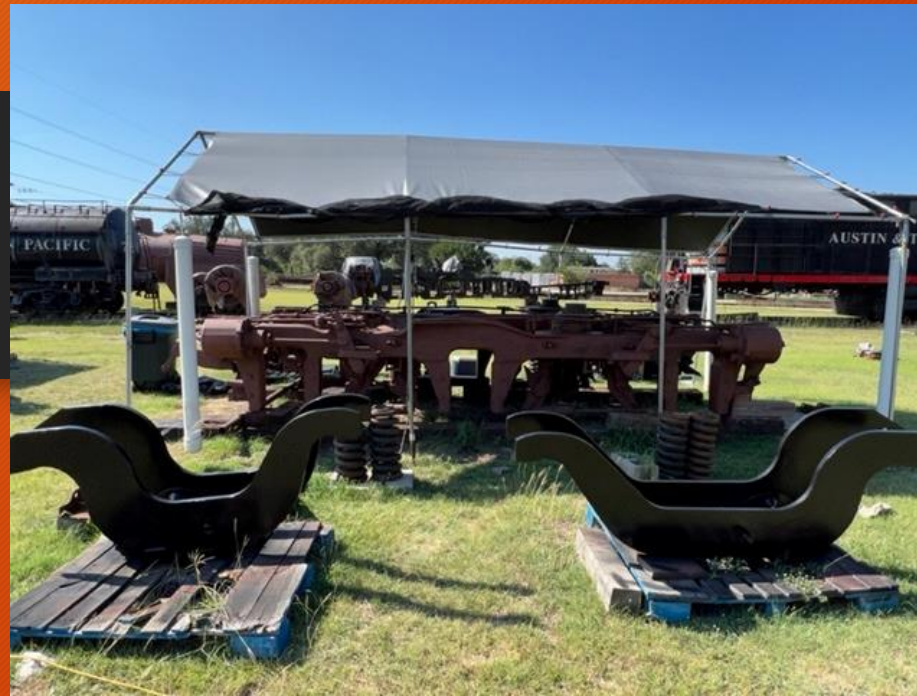
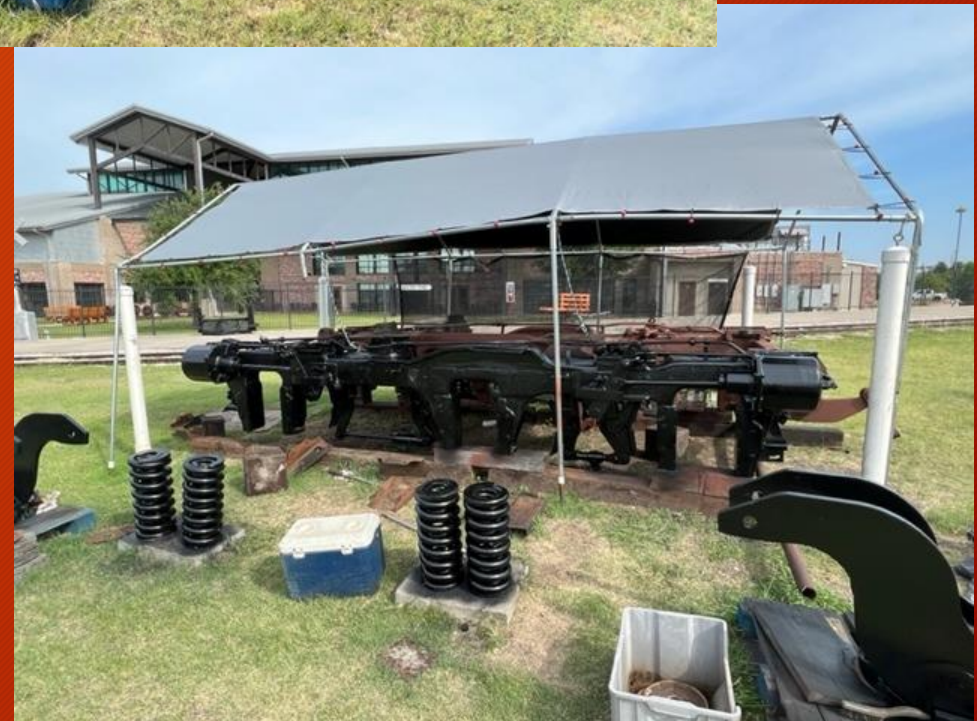
Rear Truck Repaired and Painted

- The rear truck was cleaned, and wire brushed down to fresh metal. This removed all rust and dirt that would contribute to corrosion in the future.
- The frozen brake rigging parts were dismantled, repaired, and greased to allow free and easy use and movement.
- The frozen brake adjusters were repaired and greased for ease of use.
- The trucks were primed and then painted a high gloss black.

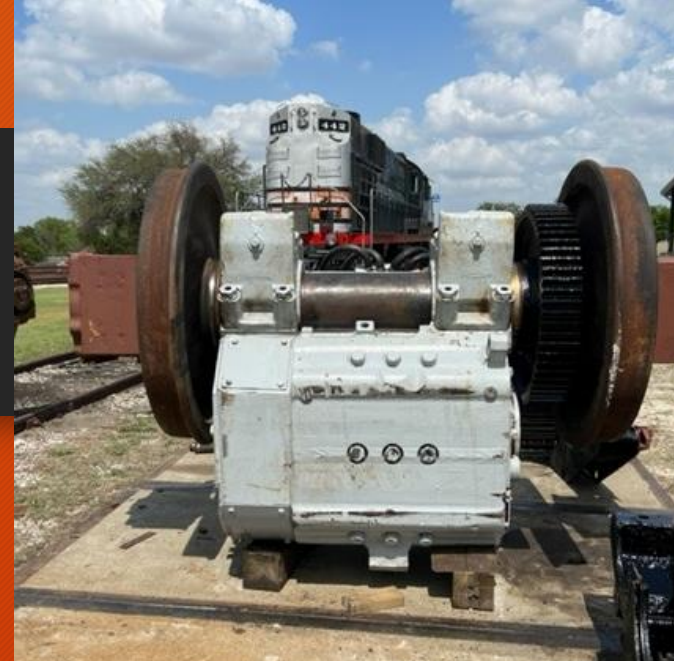
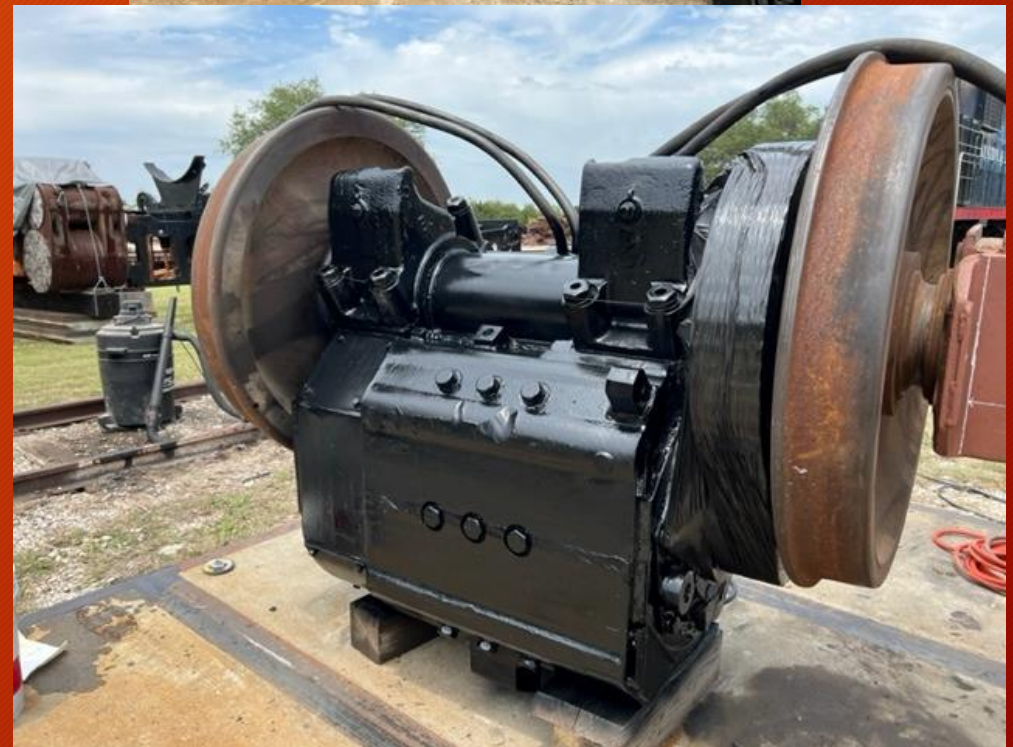
Traction Motor #5 Replacement

- TM #5 was replaced with a rebuilt TM.
- Upon replacement, the dust covers and TM support bearing boxes were sealed with RTV high temp. and high oil resistance silicon.
- The gear box seals are also renewed.
- The new TM was then painted.

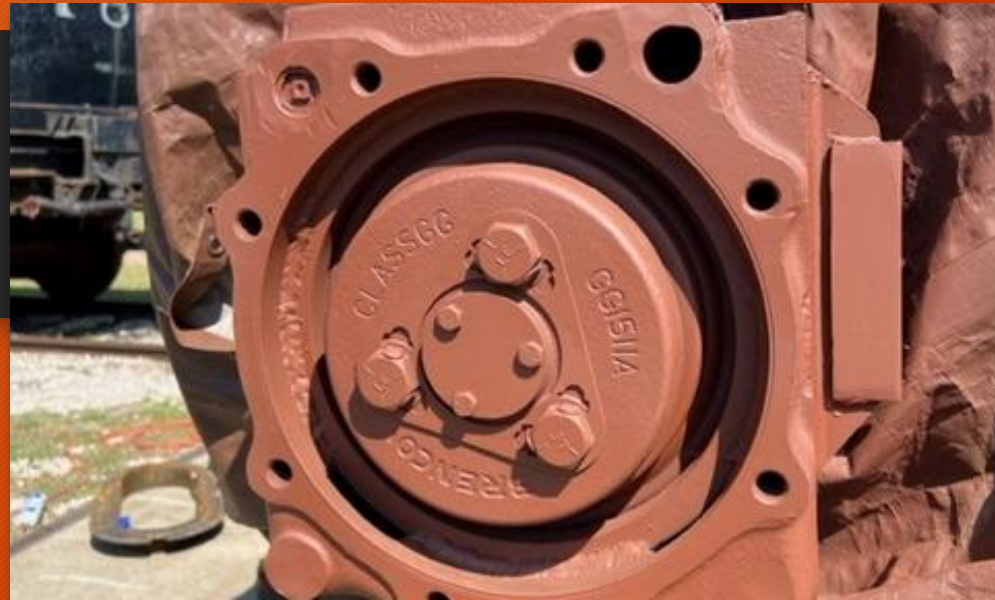
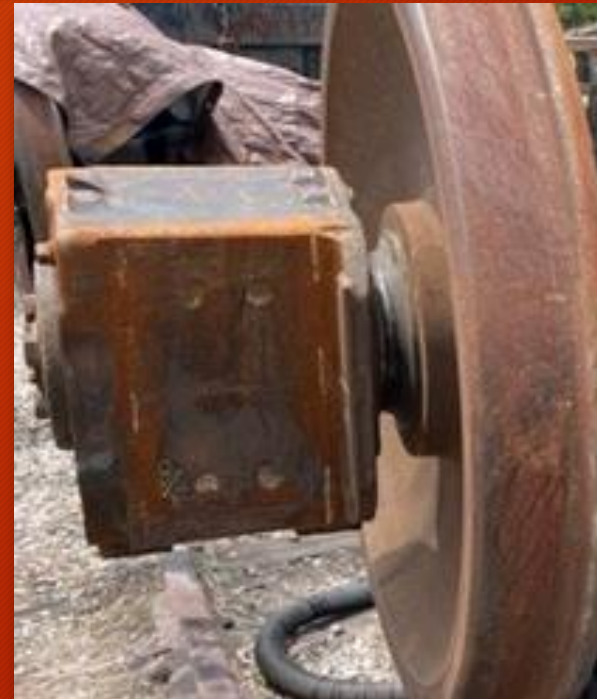
Weld Metal Shims onto Journal Boxes

- Each journal box requires a metal shim on each side.
- These are used as wear plates that ride on the inside of the pedestal liners.
- The metal is a high strength metal that is good for long term wear.

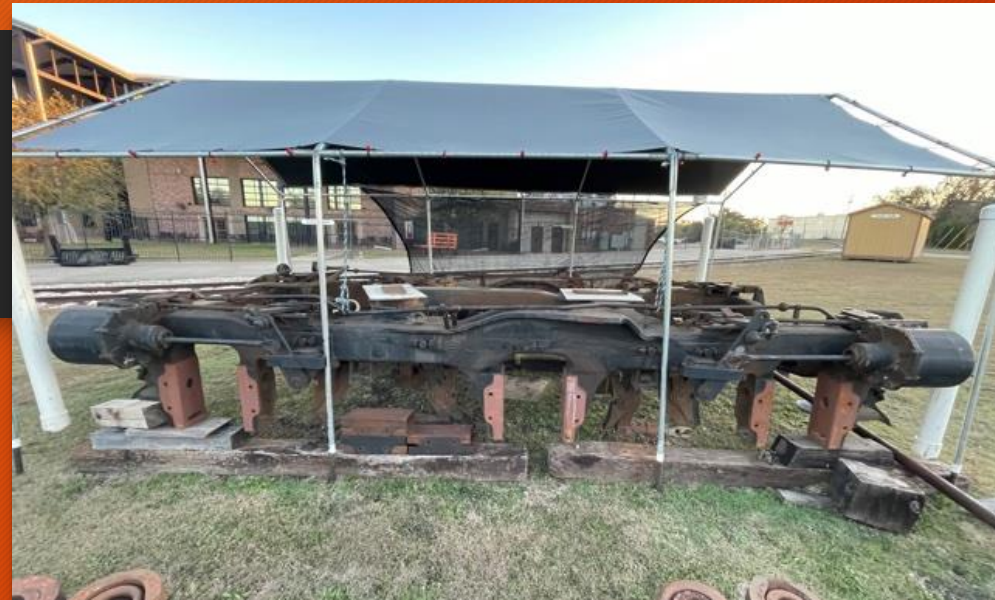
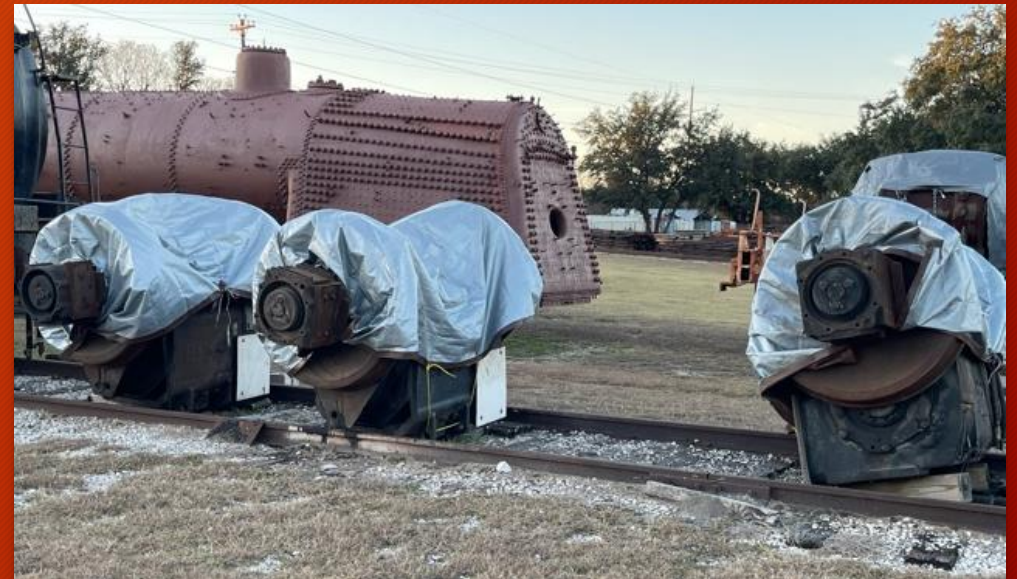
Install TM Combos Onto Rear Truck

- Use a forklift and boom truck to lift the truck and TM combos (TM and wheel/axle set).
- Reinstall TM combos back into the proper positions on the rear truck.
- Reinstall the equalizer adapters and equalizers.

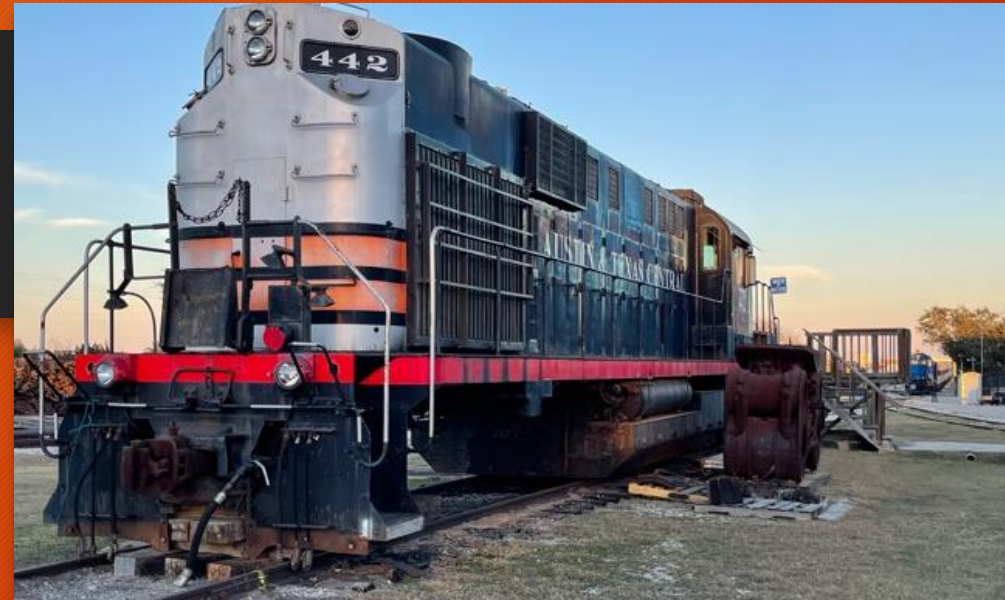
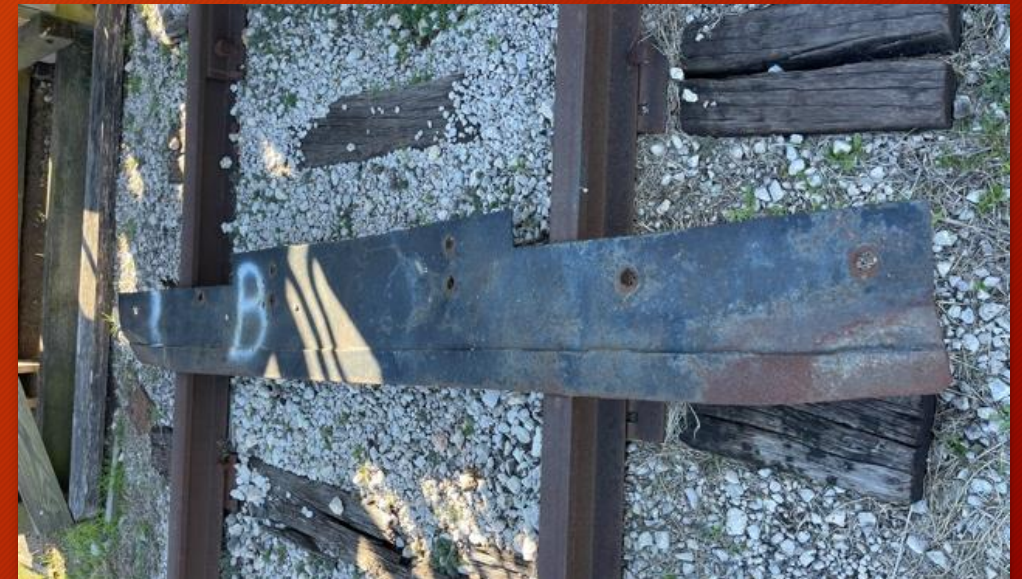
Reinstall Rear Truck

- Lift locomotive and roll truck back under locomotive.
- Reattach all TM electrical cables.
- Reattach all air lines.
- Reattach side bearings and all fasteners.
- Reattach air cooling ducts to TMs.
- Reinstall rear pilot sheet, or fabricate new pilot sheet if required.
- Test operation of rear truck.
